**R 852-IV**

CIVIL ENGINEERING LABORATORY  
Naval Construction Battalion Center  
Port Hueneme, California 93043

**CONTAINER OFF-LOADING AND TRANSFER SYSTEM (COTS)**  
**Advanced Development Tests of Elevated Causeway System**

VOLUME IV — FENDER SYSTEM AND LIGHTERAGE MOTIONS

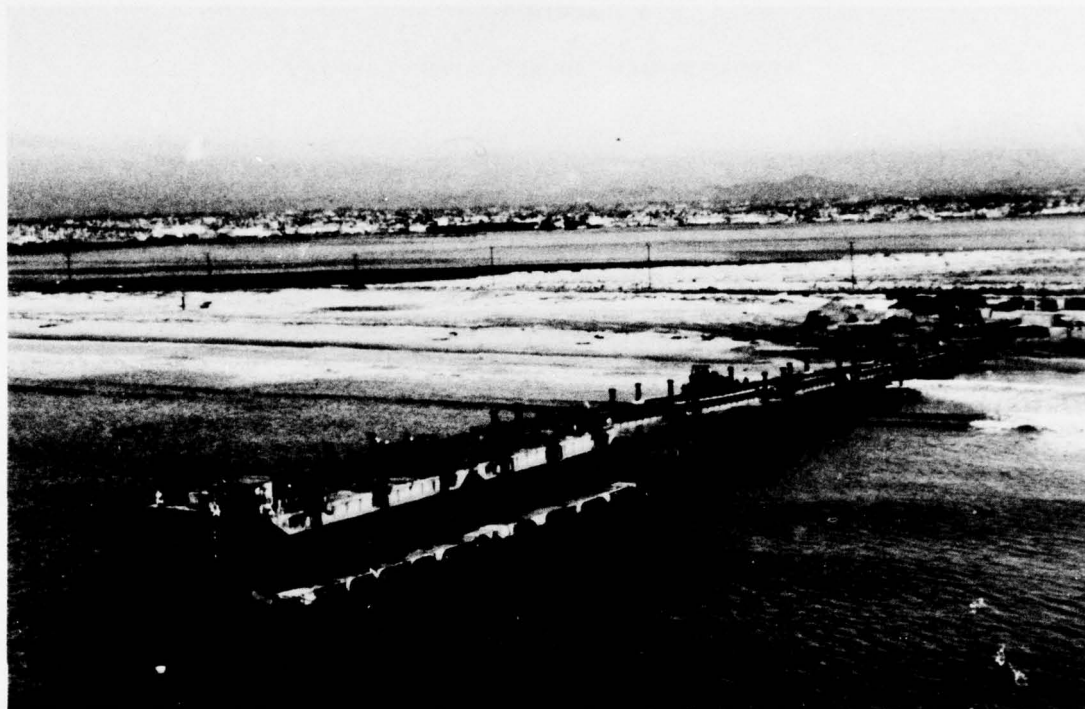
Figure 1-1. COTS elevated causeway.

The elevated causeway is comprised of a number of 3x15 NL pontoon sections [21.0 feet (6.4 m) wide and 90.0 feet (27.4 m) long] which are end-linked and side-connected together and supported clear of the water surface by steel piles (see Figure 1-1). Individual 3x15 pontoon sections arrive at the shore site aboard Navy LSTs and LSDs or aboard commercial bargeships. They are unloaded, linked together at sea to form the desired causeway configuration, and then beached. Steel piles that are inserted through spudwells in each pontoon section are driven into the sea-floor. After the end and side connections are disconnected, individual causeway sections are elevated into position by portable hydraulic jacks atop the piles. The end and side connections are re-established, the fender system is installed, and the elevated causeway is ready to function as a cargo unloading pier.

An essential subsystem of the COTS elevated causeway is the fender (see Figure 1-1). The purpose of the fender is to absorb the kinetic energy of the cargo lighters during berthing and to prevent contact between the lighters and the pier support piling. After a preliminary conceptual design study it was decided that the fender should be configured to capitalize on standardized Navy NL pontoon equipment and commercially available off-the-shelf hardware. General performance standards to be met included:

The Coronado elevated causeway (Figure 1-1) was comprised of nine 3x15 NL pontoon causeway sections. Four sections were aligned two abreast to form a pierhead at the seaward end of the causeway. The fender system, consisting of two 1x15 strings instead of the single unit used during the Phase I tests, was installed alongside the south-facing edge of the pierhead (Figure 1-7).

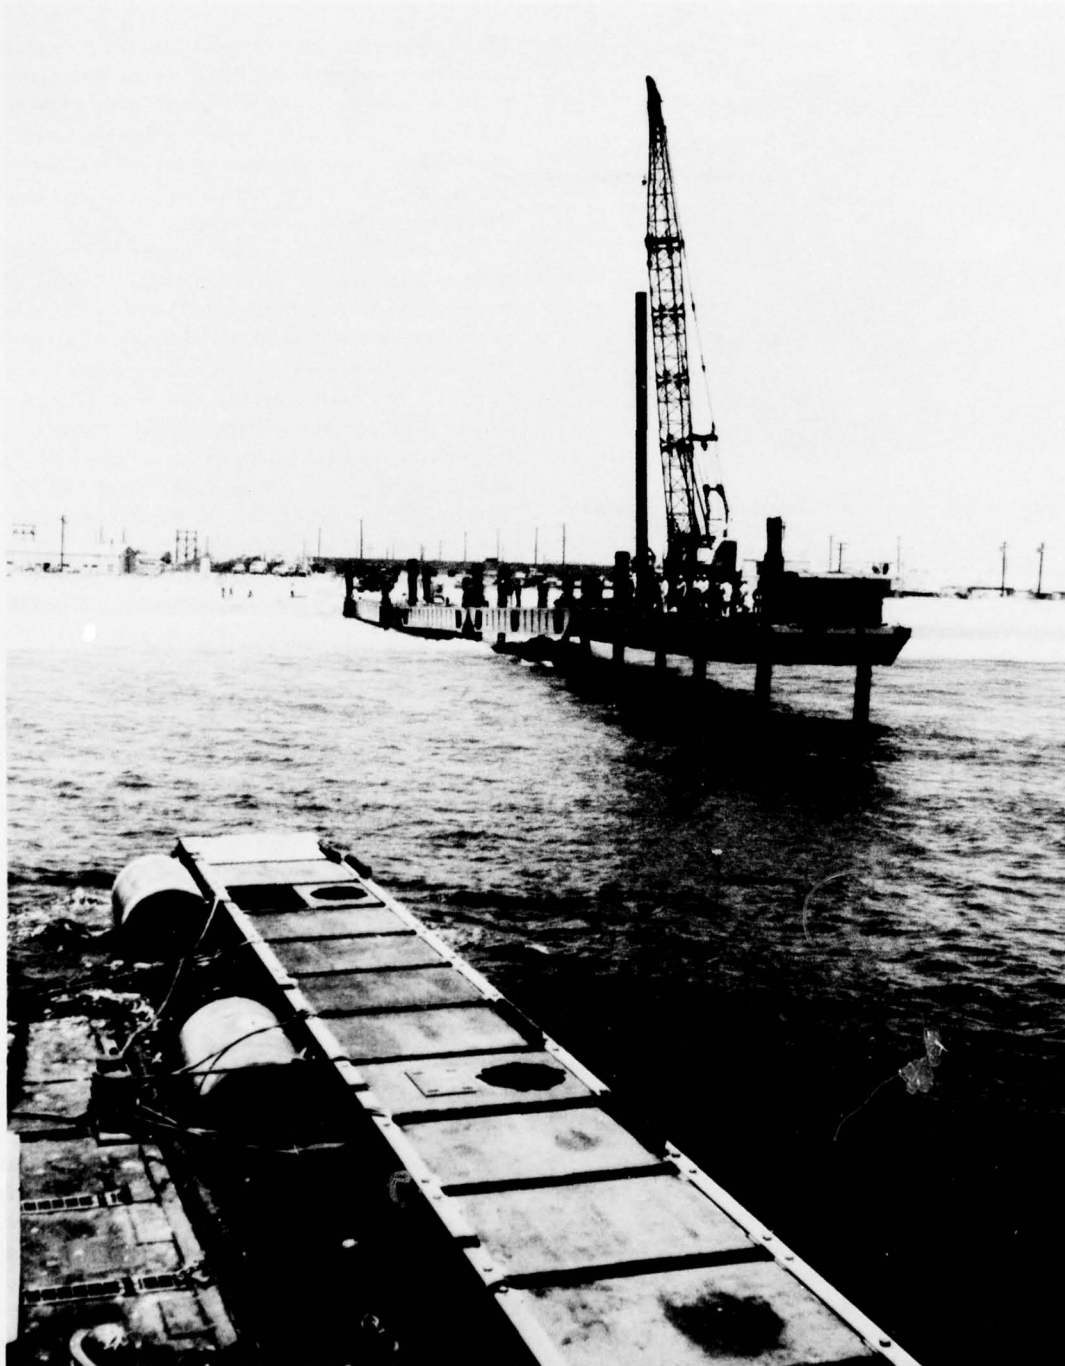
Figure 1-5. Fender unit approaching elevated pier. Note 50-foot (15.2-m) piles ready for dropping into center spudwell of fender unit.

After assembly at Port Hueneme, the fender was towed approximately 4 miles (6.4 km) to the test site (Figure 1-5), where it was installed alongside the elevated causeway. Four personnel were required for the warping tug operation: a pilot, one operator, and two line handlers. While the warping tug was preparing for its initial approach, the shore crew positioned a TD-25B tractor for use as a deadman for the bow wire of the tug. The pier crew, which was composed of a crane operator, an oiler, and two riggers, positioned a 50-foot (15.2-m) tipped pile into the center external spudwell on the elevated pier using a 35-ton (31,800-kg) mobile crane. The pile was held aloft to be inserted in the middle spudwell on the fender string, as shown in Figure 1-5.

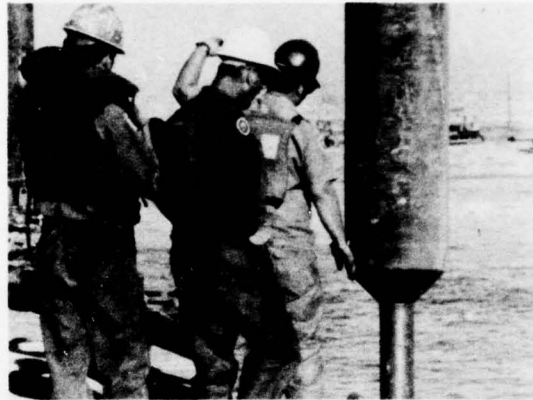
Figure 1-9. Deck crew prepared to drop first fender pile.

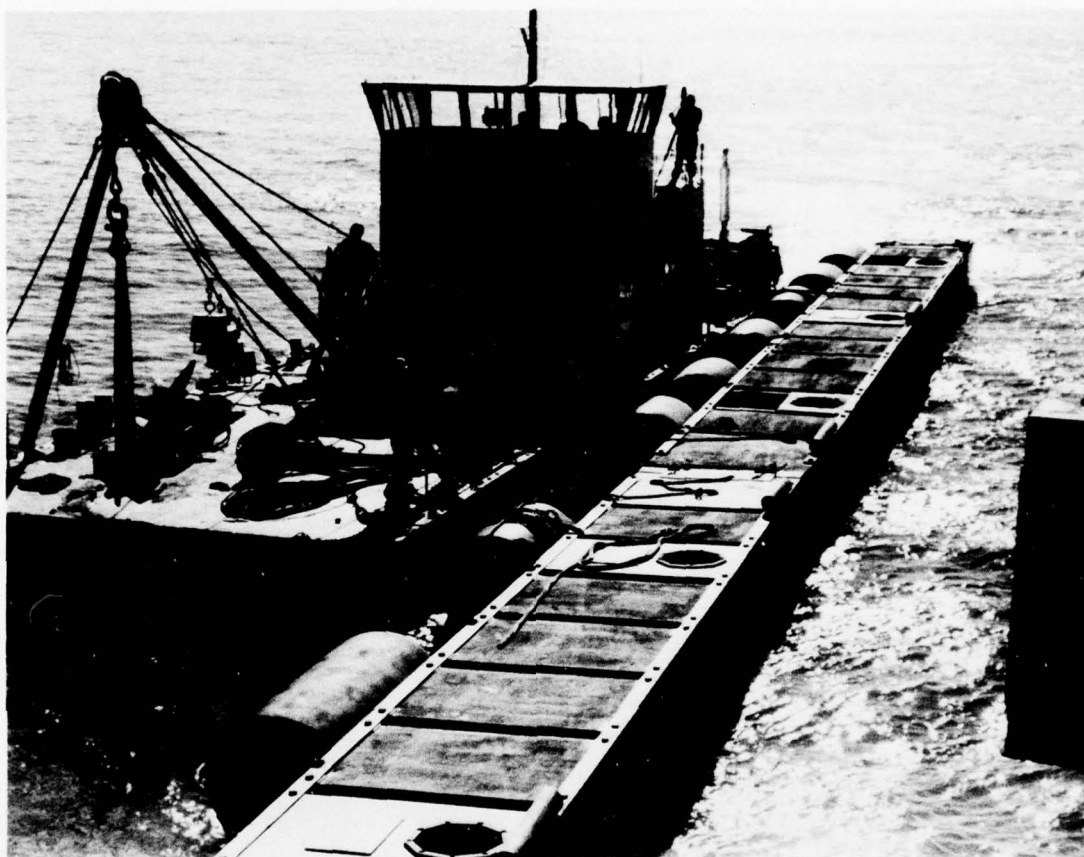
Figure 1-11. PHIBCB-ONE warping tug with fender in tow approaches elevated causeway — 24 November 1975.

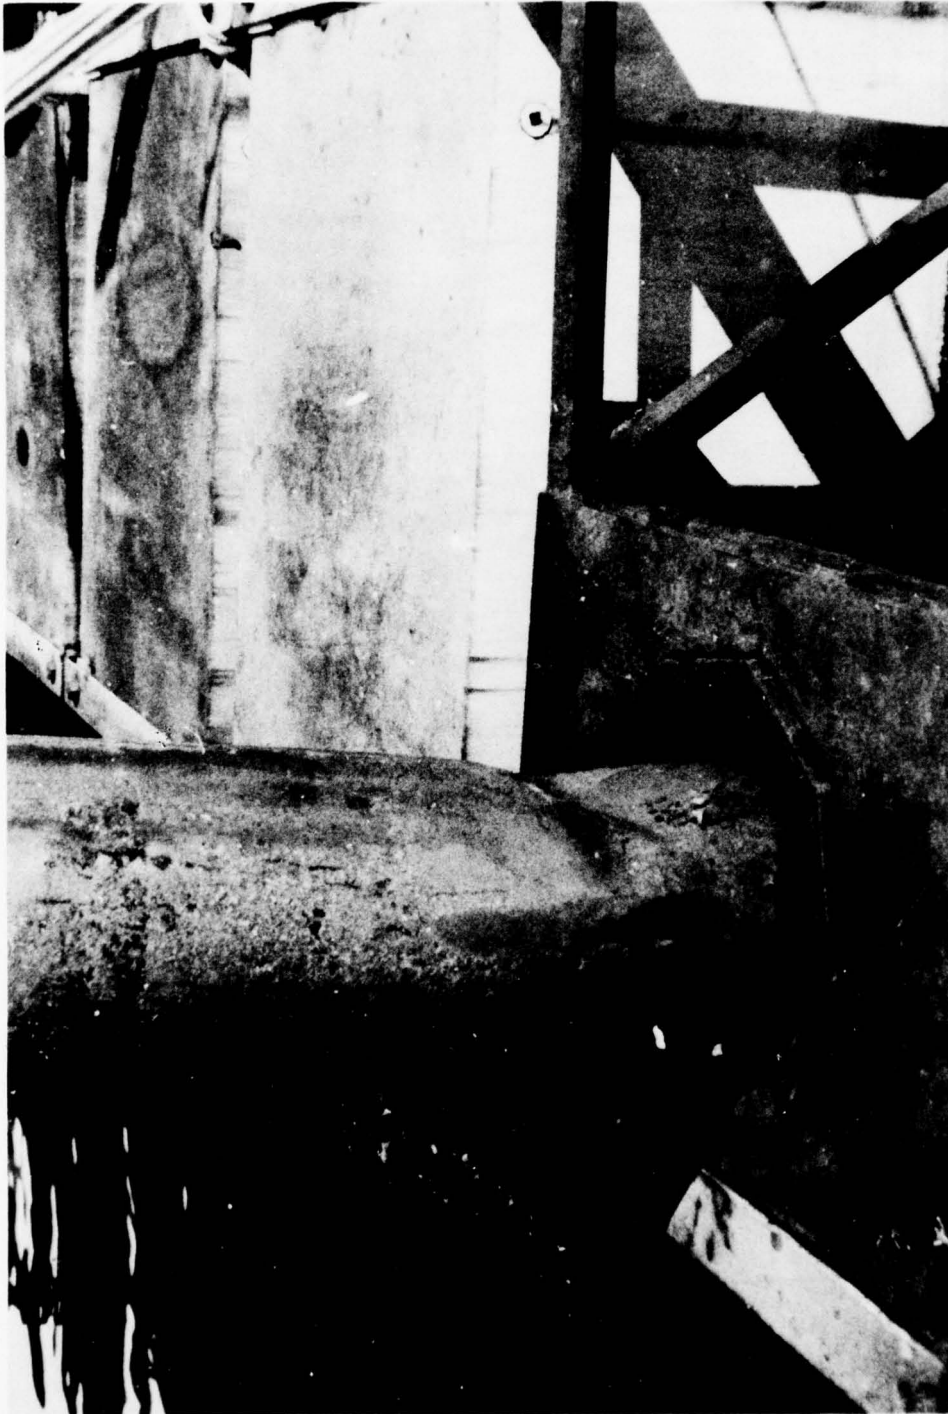
Figure 1-21. Failed fender pile.

Damage to the fender system was confined to pile failure, a bent 6-inch (15.2-cm) NL pontoon top assembly angle, and several buckled flanges on structural members in the seaward-most spudwell. However, the fender was still functional after completion of the impact tests.

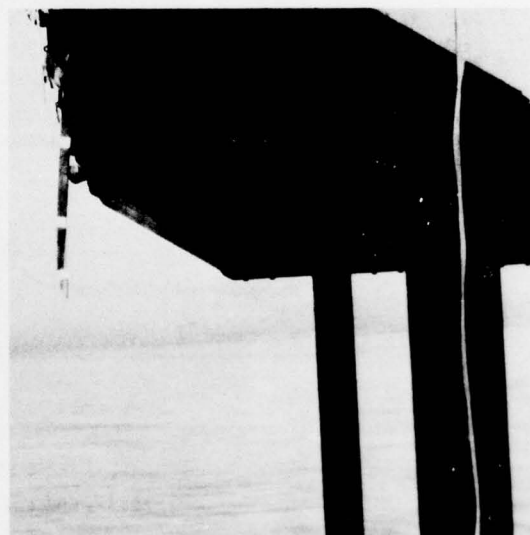
Figure 2-10. Wesmar ultrasonic probe fixed on end of elevated causeway.
